ABS-0500

Acoustic beamforming applications in construction

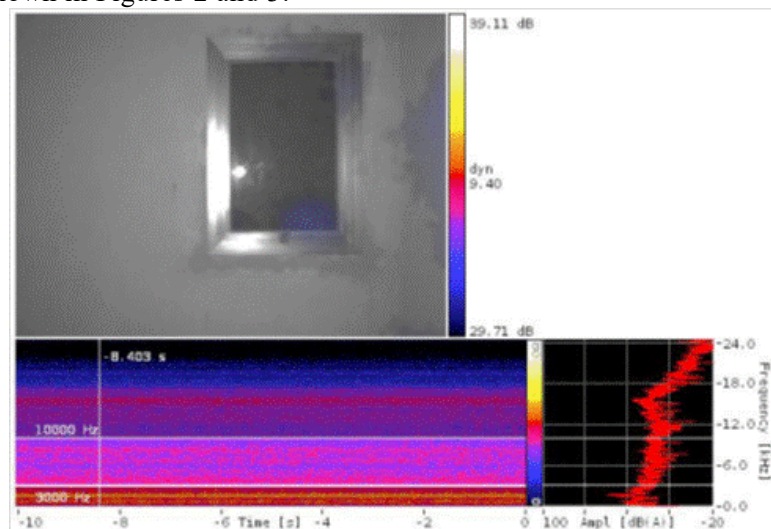
Figure 2 – Results: Framing from the 3rd floor

In this case, as can be seen in Figure 2, there is no observable sound leakage from the frame. Contrary to that, the frame shown in Figure 3, which presents identical composition to the first one, showed some sound leakage pointwise which became predominant at its uppermost edge.

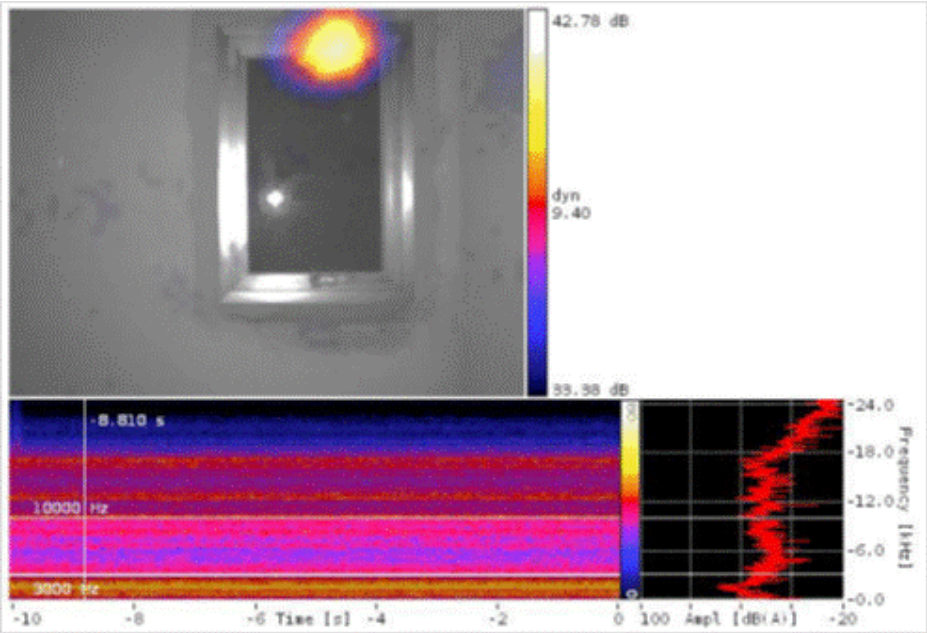
Figure 3 – Results: Framing from 12th floor

After construction workers carried out an inspection to find out the causes for such leakage, it was found out lack of mortar in the framing’s upper edge. In situations like that, it would not have been possible to spot this fault from visual inspection alone, given that the framing structure conceals such area. It demonstrates beamforming measurements effectiveness.

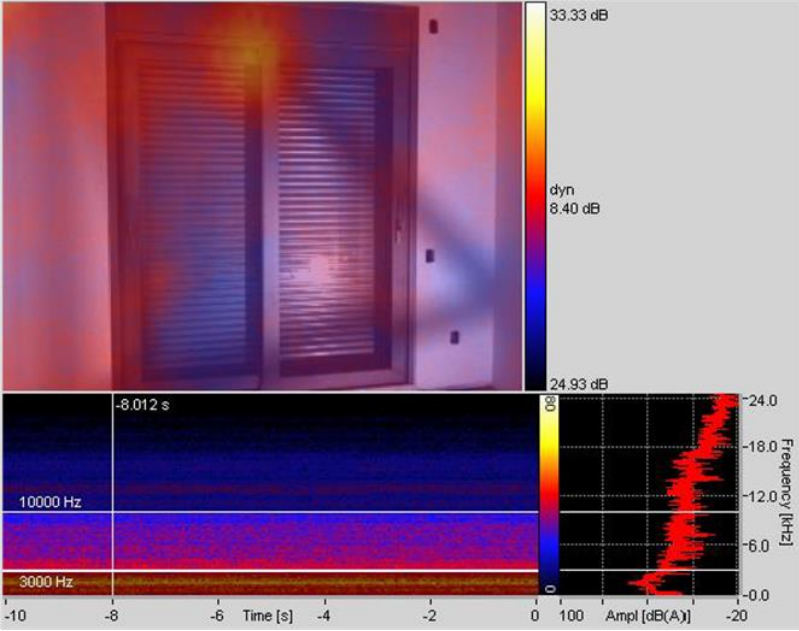
Once again, the study was carried out on samples from the same framing on different floors within the building. The door under test, as shown in Figure 5, had been correctly installed, seeing that the pointwise leakage detected in its upper central portion (panel junction) is due to framing configuration. In Figure 6, which shows the tests for a door from another floor. One can notice a specific sound leakage, which is predominant in the upper portion of the door's left panel.

Figure 5 – Results: Balcony Door from 5th floor

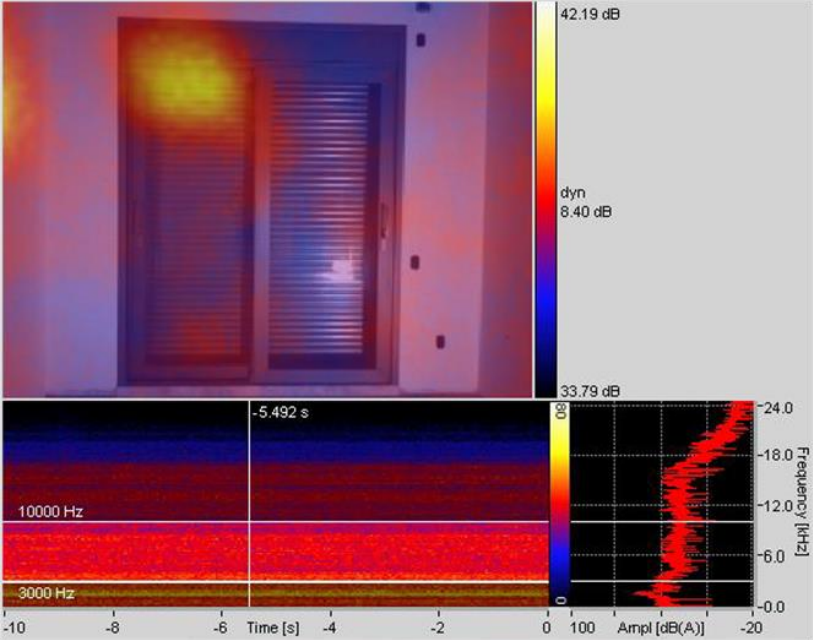
Figure 6 – Results: Balcony Door from 6th floor

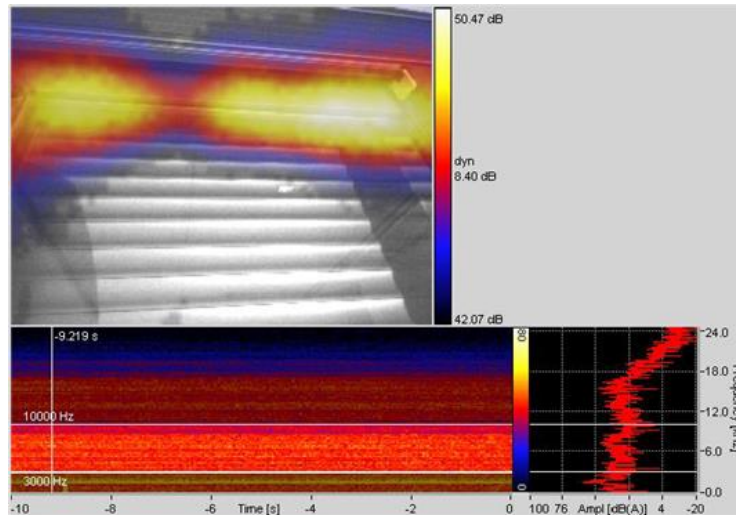
By approaching the acoustic camera to the leakage area (Figure 7), it became possible to conclude that sound was being transmitted through an existing gap between glass and sash, due to the lack of a sealing element around its edge, as shown in Figure 8. Thanks to such assessment, the construction team carried out an inspection on all the building's doors, performing repairs as needed.

Figure 7 – Results: Door's left panel in detail

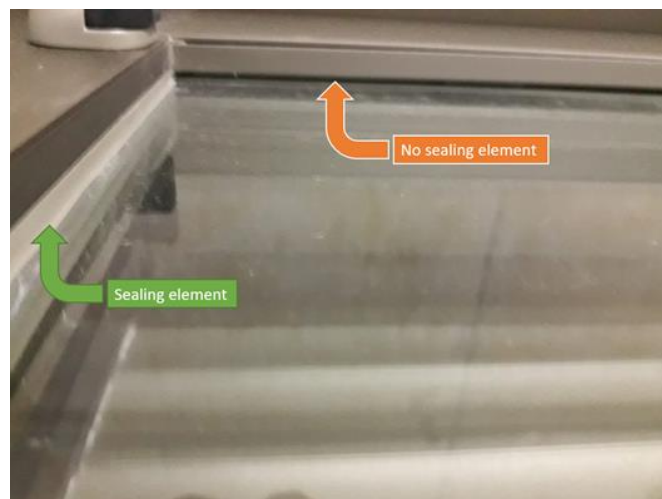
Figure 8 – Lack of sealing element

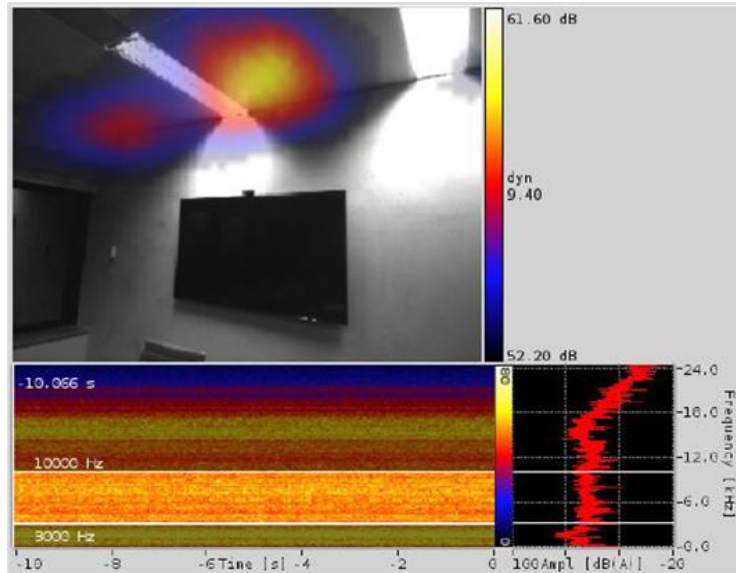
Upon assessing the results, it became possible to notice that the predominating sound leakage came from the ceiling and not from the partition itself. After close investigation with those in charge of the construction, a peculiar characteristic of the building's air conditioning system was identified: there were microperforations in the ceiling and the rooms got mutually connected, since the partition height extended up to the ceiling only. Therefore, the sound emitted in one of the rooms would enter the ceiling through these microperforations, reaching the adjacent room through the same path.

Figure 9 – Results: Ceiling-bound sound transmission

Due to the precise diagnosis provided by the beamforming assay, it became possible to act directly upon the core of the problem by improving the sound insulation between rooms.

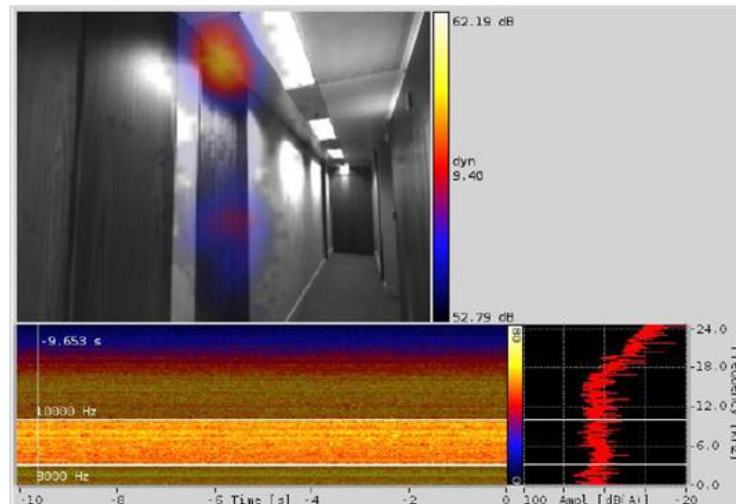
Measurements have also been carried out between one of the meeting rooms and the office reception. In this case, the door was identified as the weaker element, responsible for most of the sound transmission taking place. There was a large gap in this door's upper portion that would be hard to be noticed visually due to ceiling placement. Nonetheless, it was detected after the beamforming assay had been performed, as shown in Figure 10.

Figure 10 – Results: Door-bound sound transmission

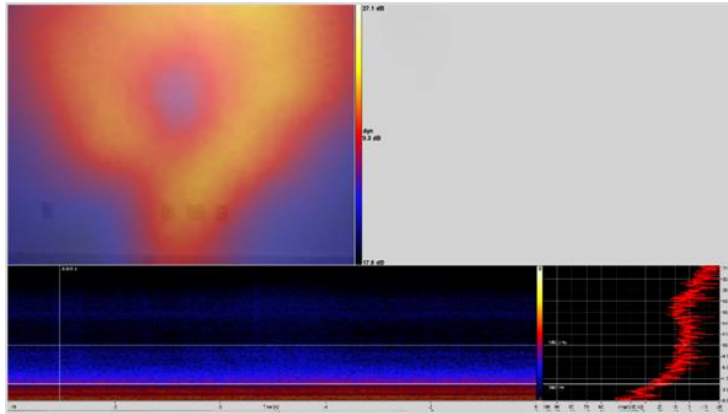
Initially, the perception was that sound transmission took place smoothly all along the partition. However, upon performing a full-wall scan, pointwise leaks were spotted from the electrical switchboxes, according to the results shown in Figures 11 and 12.

Figure 11 – Results: Wall-bound sound transmission

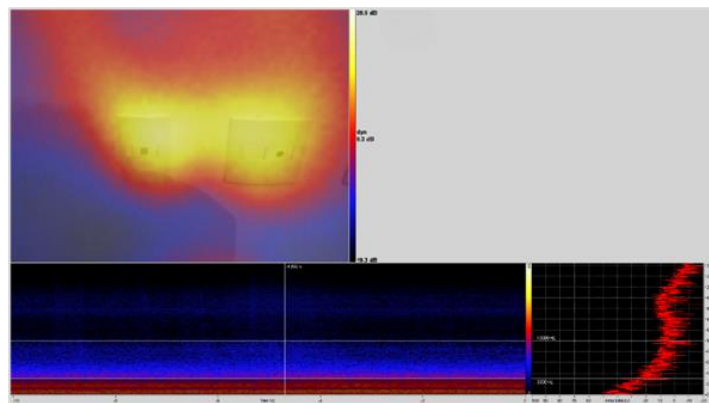
Figure 12 – Results: Sound leakage on electrical switchboxes

Once the source of leakage had been identified, an immediate solution was used: fulfill the referred cavity with burlap. The effectiveness of such quick solution may be verified in Figure 13. By comparing Figures 11 and 13, one can notice that the specific sound leakage from the electrical switchboxes ceased afterwards, leaving just the transmission of sound going through the wall itself.

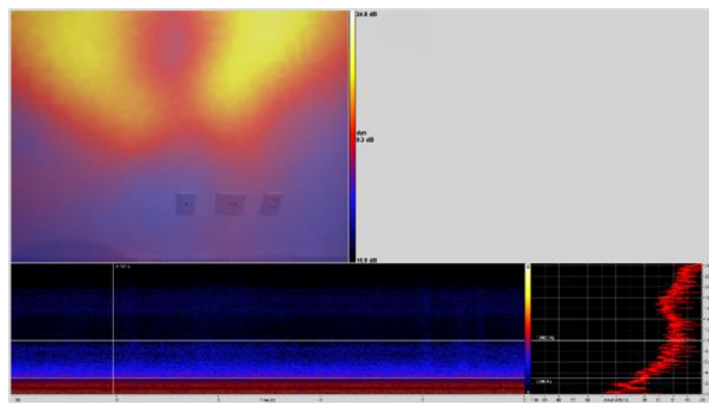
Figure 13 – Results: Wall-bound transmission after leakage isolation

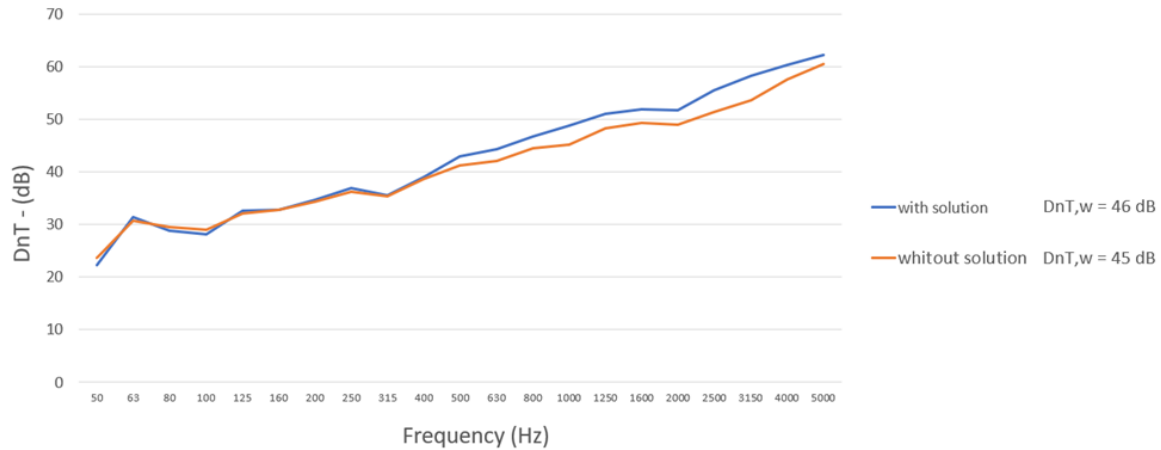
Figure 14 – Measured results for acoustic performance, shown both with and without solutions for the leakage problem.

By assessing these results, it can be observed a 1dB increase in the $D_{nT,w}$ value regarding the partition, after the correction of the sound leakage spot. Such increase is quite significant, especially in those situations when acoustic insulation values are found to be very close to the acoustic performance limit values set out by a specific standard.

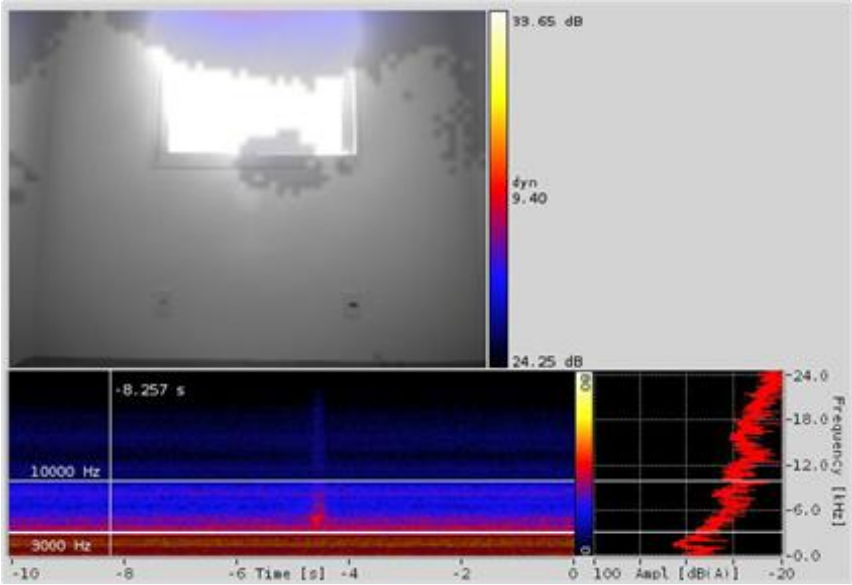
The facade was made up of masonry; however, there was an area measuring approximately 0.4 m² which had been covered with plasterboards only, to be found below the window line. This is a usual practice which makes it possible for future users to install their air conditioning systems inside bedrooms. Therefore, the first assessments aimed at checking the contributions from each constructive element through transmission means, determining which of these would be more sensitive from an insulation standpoint. Figure 16 shows the results for this study. It becomes clear that sound transmission takes place through the frame mostly.

Figure 16 – Result: Initial assessment of sound transmission through window frames

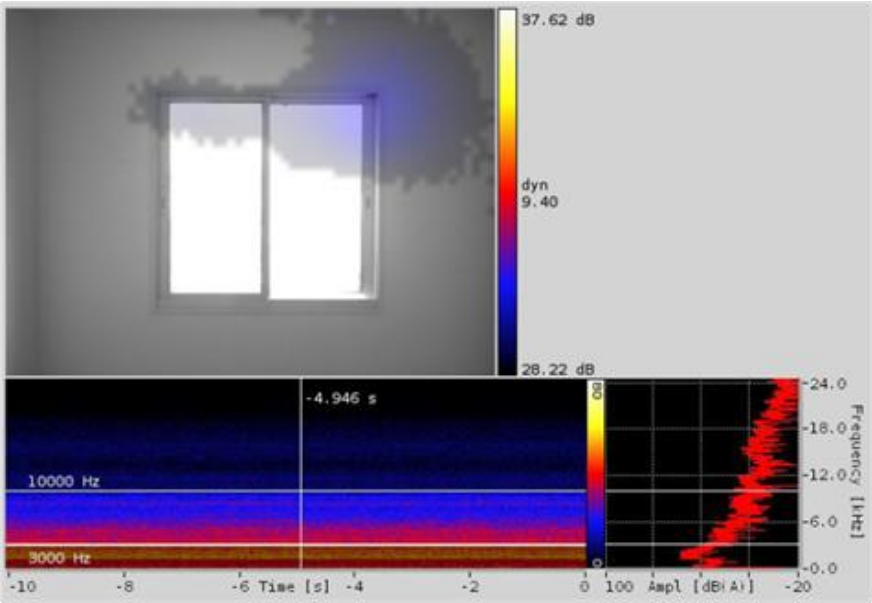
Therefore, we set out to determine which spots over the frame were the most sensitive ones. The results showed that the upper corners had sound leakage due to existing cracks in the window frames. The right corner displayed greater sound transmission range, and, for such a reason, it was the first one upon which solutions were attempted. These results are shown in Figures 17 and 18.

Figure 17 – Results: Sound transmission level assessment through window frames

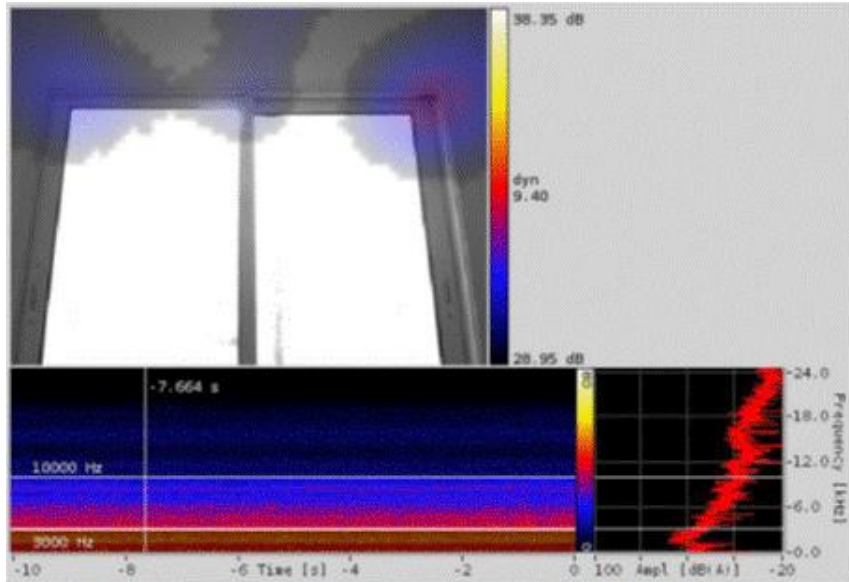
Figure 18 – Results: Approximate assessment of sound transmission by window frame

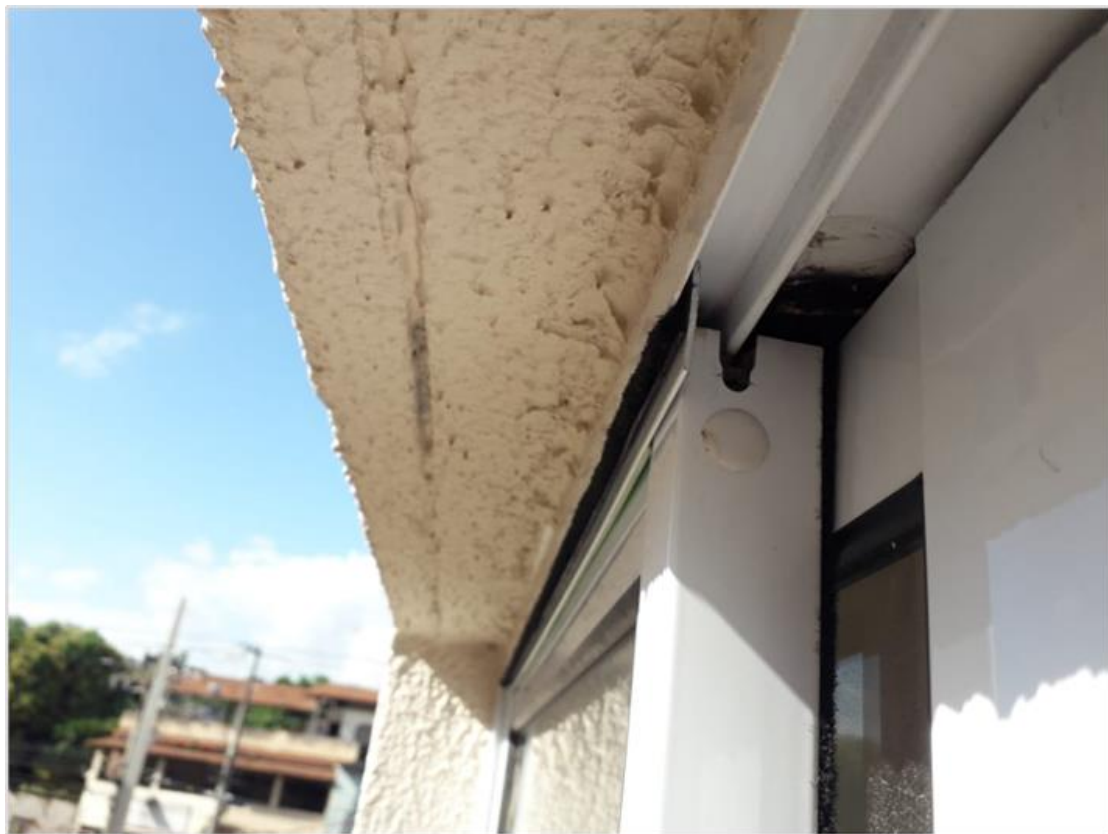
Figure 19 – Solution employed for sealing of main crevice

In order to seal the gap existing in this area, a fixed sealing element was added on the outer side of the frame. Such element sealed the gap existing between rail and window frame, without impairing frame movement. Figure 19 shows the solution already installed.

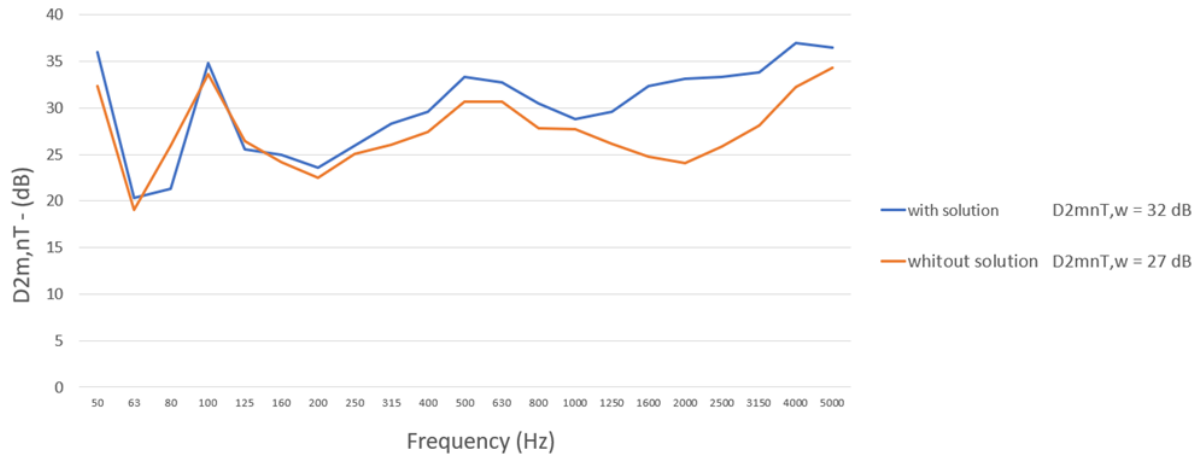
Figure 20 – Measured results for acoustic facade insulation, both before and after a solution was fitted in.

When evaluating the results, one can notice that such solution significantly increased performance by 5 dB, as the value found for $D_{2m,nT,w}$ reached 32 dB. It is also noticeable the improved performance from 1000 Hz upwards, caused by the crevice's sound transmission characteristic.
