ABS-0500

Acoustic beamforming applications in construction

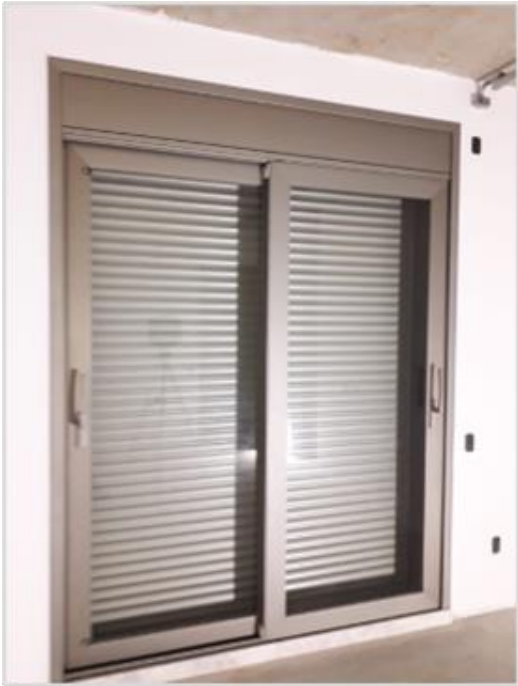
Figure 4 – Balcony doors

Once again, the study was carried out on samples from the same framing on different floors within the building. The door under test, as shown in Figure 5, had been correctly installed, seeing that the pointwise leakage detected in its upper central portion (panel junction) is due to framing configuration. In Figure 6, which shows the tests for a door from another floor. One can notice a specific sound leakage, which is predominant in the upper portion of the door's left panel.

By approaching the acoustic camera to the leakage area (Figure 7), it became possible to conclude that sound was being transmitted through an existing gap between glass and sash, due to the lack of a sealing element around its edge, as shown in Figure 8. Thanks to such assessment, the construction team carried out an inspection on all the building's doors, performing repairs as needed.

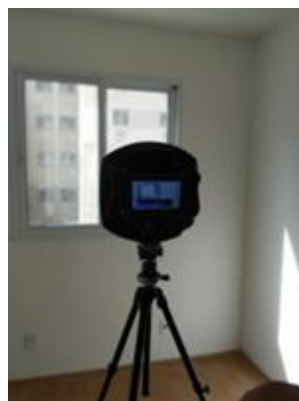
Figure 15 – Measured room

The facade was made up of masonry; however, there was an area measuring approximately 0.4 m² which had been covered with plasterboards only, to be found below the window line. This is a usual practice which makes it possible for future users to install their air conditioning systems inside bedrooms. Therefore, the first assessments aimed at checking the contributions from each constructive element through transmission means, determining which of these would be more sensitive from an insulation standpoint. Figure 16 shows the results for this study. It becomes clear that sound transmission takes place through the frame mostly.

Therefore, we set out to determine which spots over the frame were the most sensitive ones. The results showed that the upper corners had sound leakage due to existing cracks in the window frames. The right corner displayed greater sound transmission range, and, for such a reason, it was the first one upon which solutions were attempted. These results are shown in Figures 17 and 18.
